SCHUYLKILL RIVER BASIN
ANTIETAM CREEK, BERKS COUNTY
PENNSYLVANIA

ID NO. PA.00716

LAKE ANTIETAM DAM

PHASE I INSPECTION REPORT NATIONAL DAM INSPECTION PROGRAM

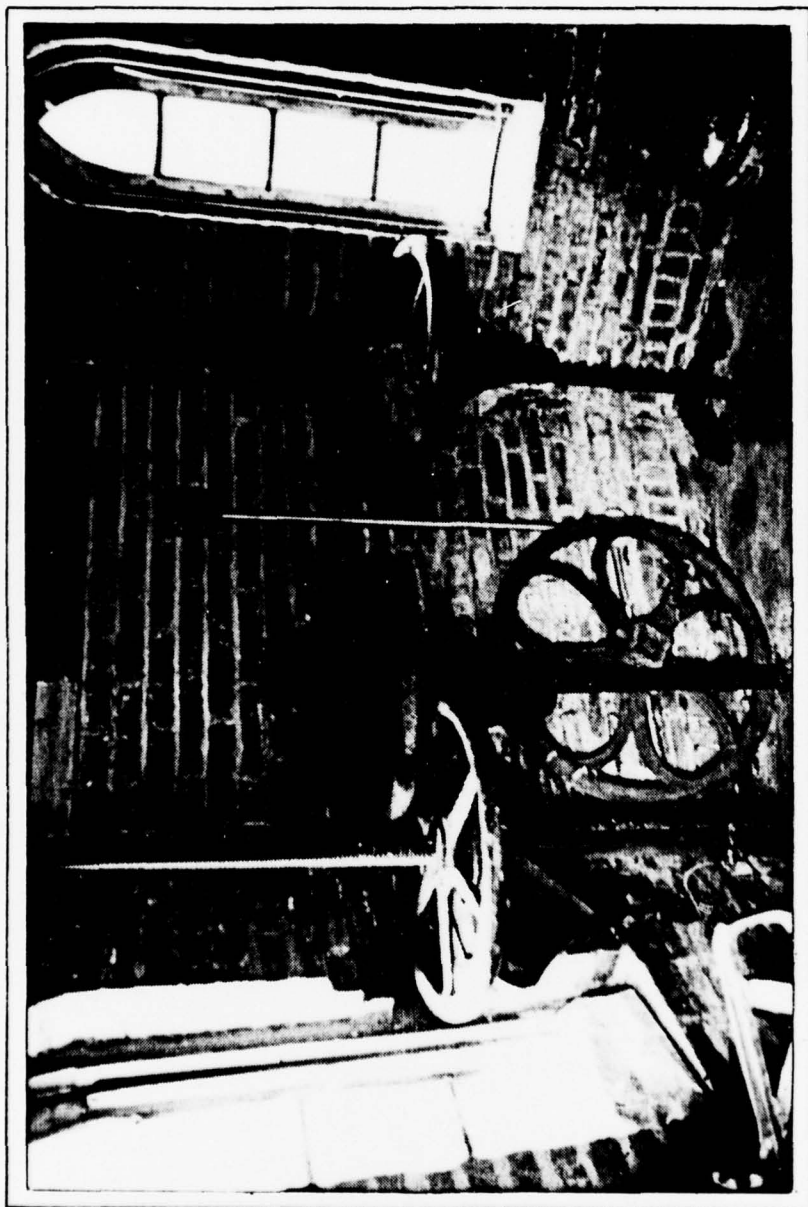
PHOTOGRAPH NO. 2

VIEW INSIDE CONTROL TOWER. GATE
VALVES ARE NON FUNCTIONAL.

2. The valve should be cleaned, lubricated and restored to an operable condition so that it functions properly in the event of an emergency.
3. The spillway stability should be reassessed by a registered professional engineer and rehabilitated in accordance with the engineer's recommendations. This rehabilitation would include restoration of the channel walls and realignment of the spillway crest and possibly anchorage of the spillway capstone.

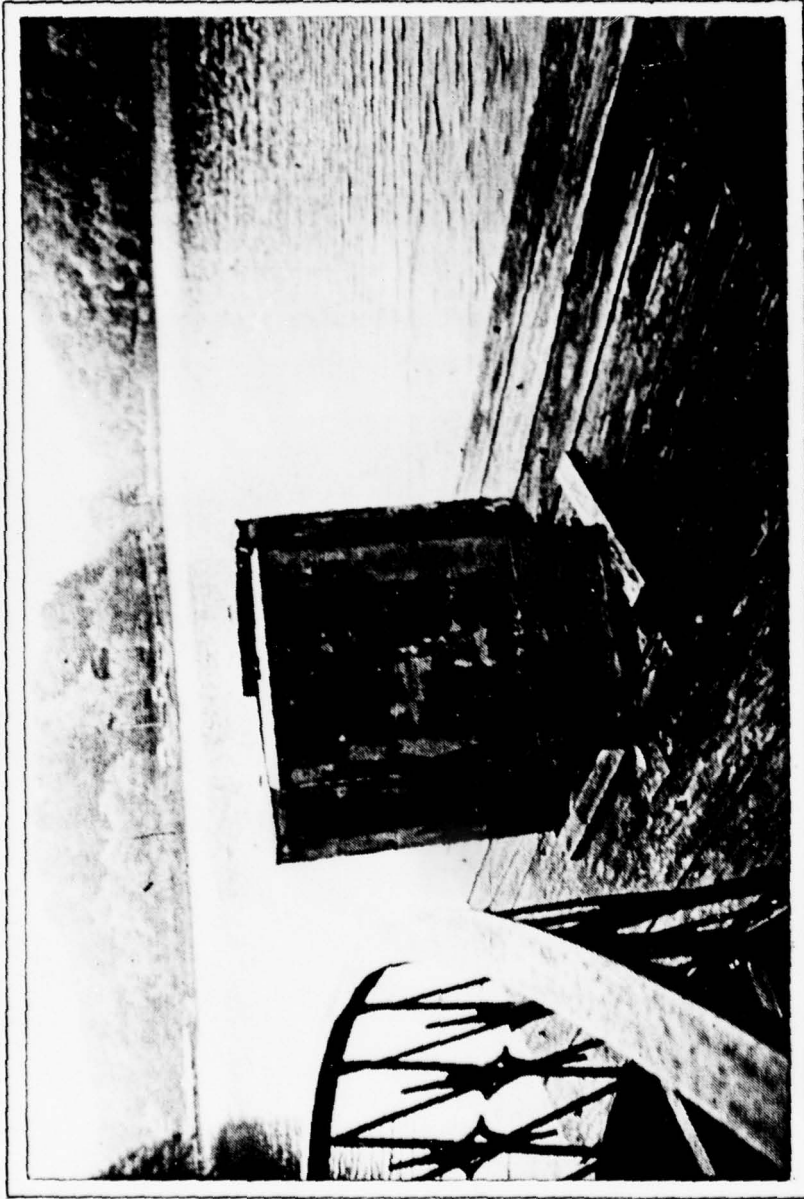
PHOTOGRAPH NO. 3

VIEW OF THREE GATE VALVES INSTALLED
ABOUT 1914. THEIR PURPOSE IS
UNKNOWN.

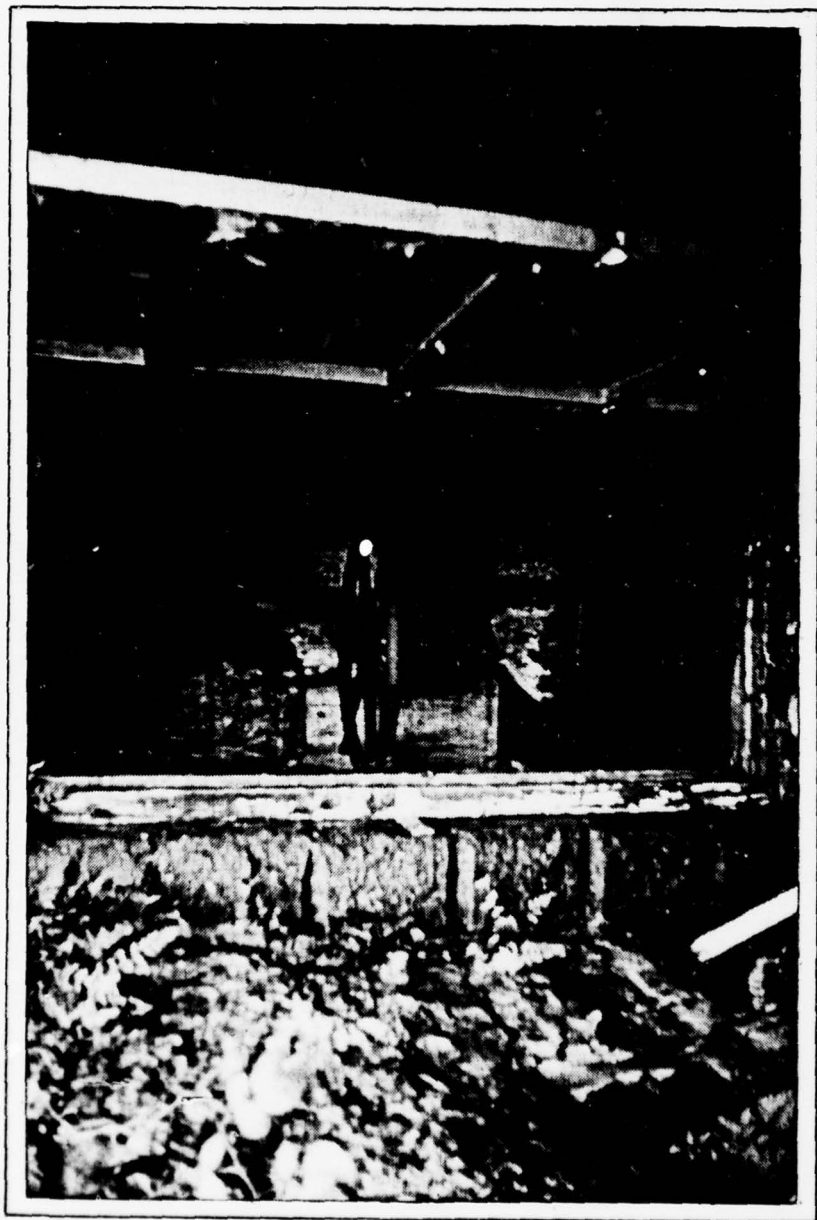
The pond drain valve was inspected and assessed to be in poor condition. The base of the valve house is flooded with water to the doorsill, covering about one half of the pipe. In the winter, this water could freeze, rendering the system inoperable. The gear mechanisms are rusted and the system does not appear to be very well maintained.

VIEW OF GATE HOUSE AND POND DRAIN
VALVE.

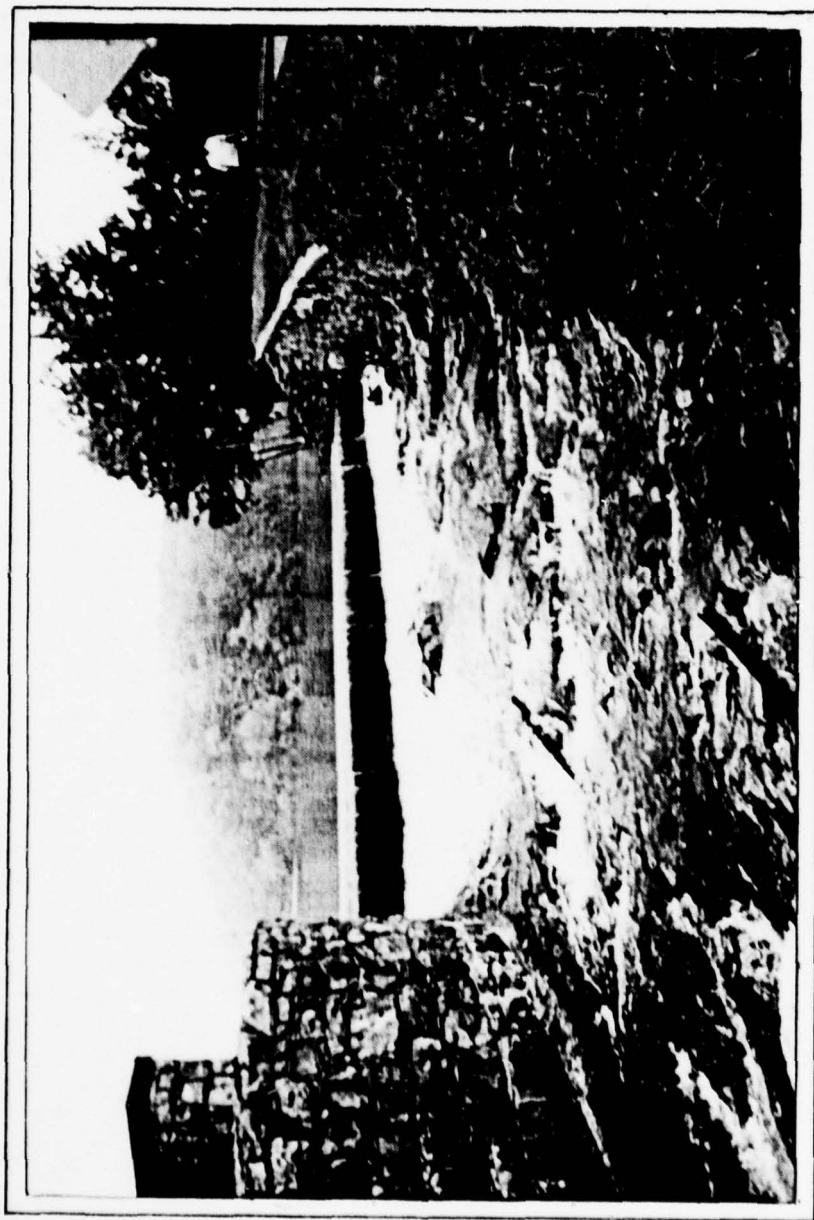
PHOTOGRAPH NO. 5

The spillway consists of a rubble masonry wall topped with a granite capstone. Its total height is approximately 5 feet and the length is 66 feet. The upstream portion of the spillway contains a concrete apron. The downstream channel is cut into natural rock. The channel makes a 65° deflection to the south around the dam and necks down to 30 feet between the dam and the existing highway at the end of the spillway. The alignment of the spillway cap appears to bow downstream slightly. The vertical profile, however, looks very good. An open joint was observed between the cap and the upstream concrete apron. A detailed inspection of the spillway indicated that the base joint below the cap in the main masonry wall is fractured and deteriorated. At a few local spots the joint was open to a depth of approximately 4 inches. Also, the front edge of the cap protrudes beyond the face of the masonry wall. The supporting wall appears to be in good condition. It is judged that the cap was probably displaced due to high flows or possibly ice forces against the cap.

The emergency spillway was assessed to be in fair condition. Deterioration was noted along the rock joints and the mortared riprapped walls. Distortion of the spillway crest cap was also observed. It is assessed that this cap distortion is probably associated with ice forces or high flows over the spillway. Some minor distortions were observed along the rubble walls which are not judged to be signs of imminent instability. These walls should be reassessed and repaired as necessary, together with the spillway cap.

VIEW OF SPILLWAY LOOKING UPSTREAM.

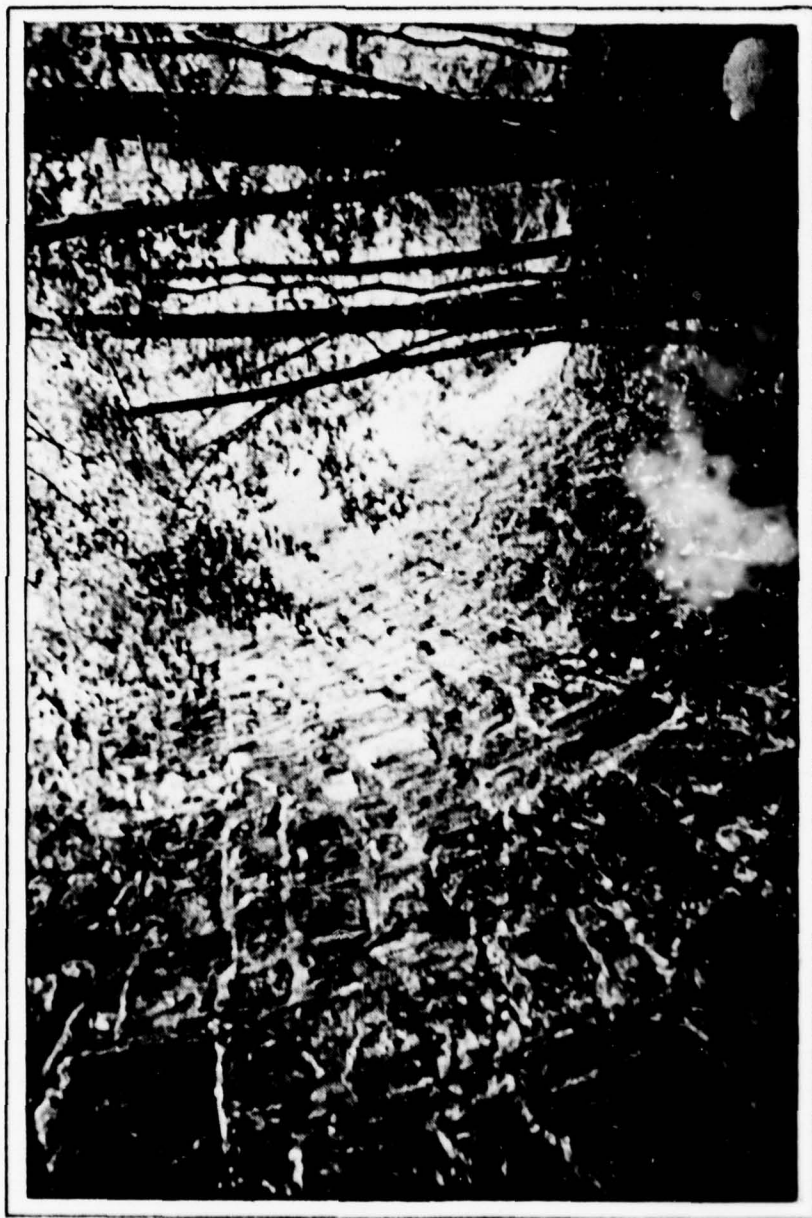
b. Dam. The horizontal and vertical alignment of the dam appears to be good. There is no evidence of displacement or settlement. The downstream face showed considerable deterioration of the masonry joints. In several locations the joints were open to a depth of approximately 12 inches. Due to the steepness of the downstream face, only the joints between the masonry blocks could be inspected. The downstream face was wet from a point approximately 15 to 20 feet below the top of the parapet wall, and small seeps were visible running through many of the joints. All seeps appeared to be clear.

VIEW OF DOWNSTREAM SLOPE OF DAM.

4. Vegetation should be removed from the downstream face of the dam and the joints repacked to minimize further deterioration. Organic materials and other debris and waste matter along the downstream toe should be removed and the area regraded. The seepage should be monitored for changes in flow rates and turbidity.

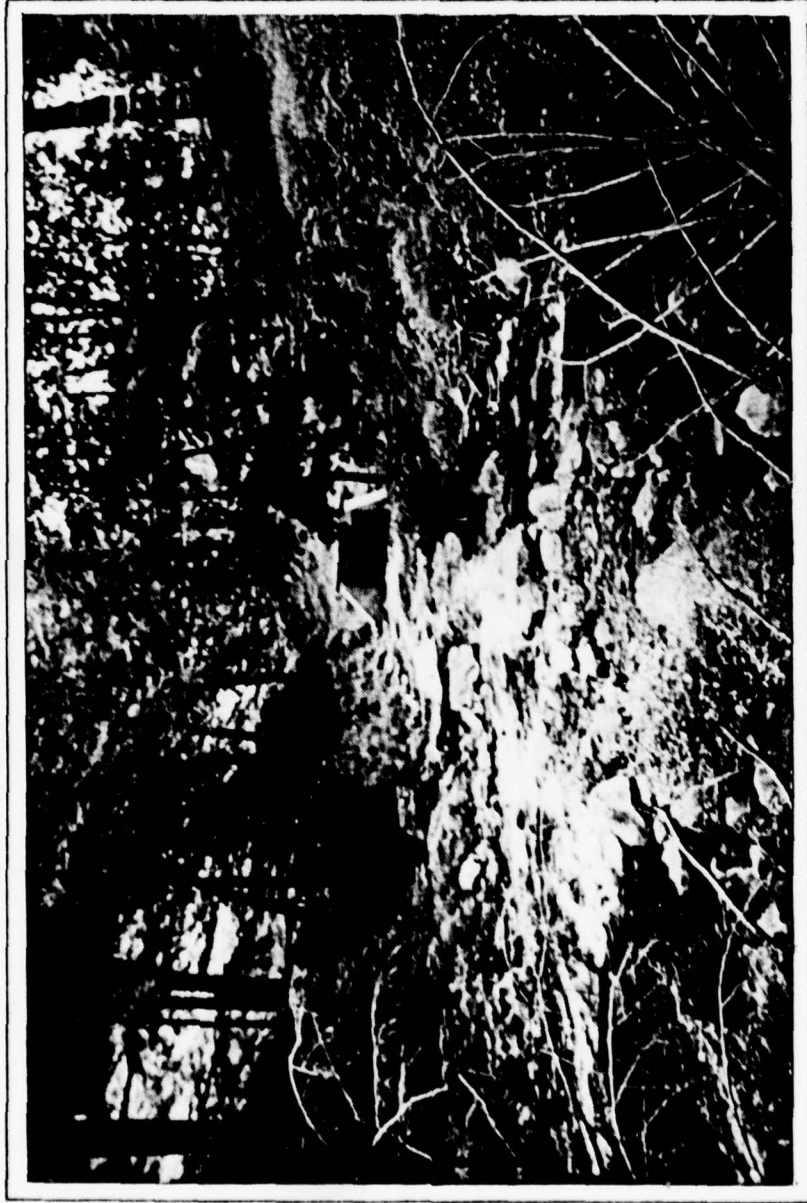
PHOTOGRAPH NO. 11

VII
VIEW FROM JUST BELOW DAM TOE LOOKING
DOWNSTREAM TOWARDS FIRST CULVERT
BELOW DAM.
